## WATER LEAK DETECTION USING FIDO AI IN ANNA (VALENCIA)

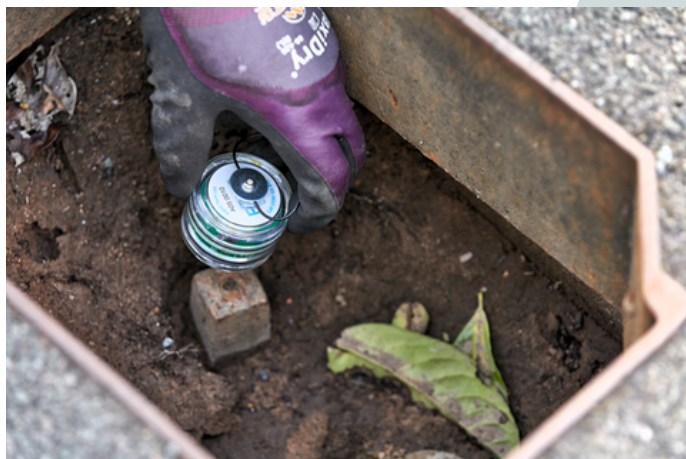
FIDO sensor installation.

The project has deployed a total of **210 acoustic sensors (bugs)** in one week, whose information has enabled a global mapping of valuable information that locates areas free of leaks and critical areas.
